Appendix K

Contract No. 13/WSD/16

Mainlaying in Tseung Kwan O

**Interim report for Complaint on 28 December
2023
(Complaint Code: 13/WSD/16_C005)**

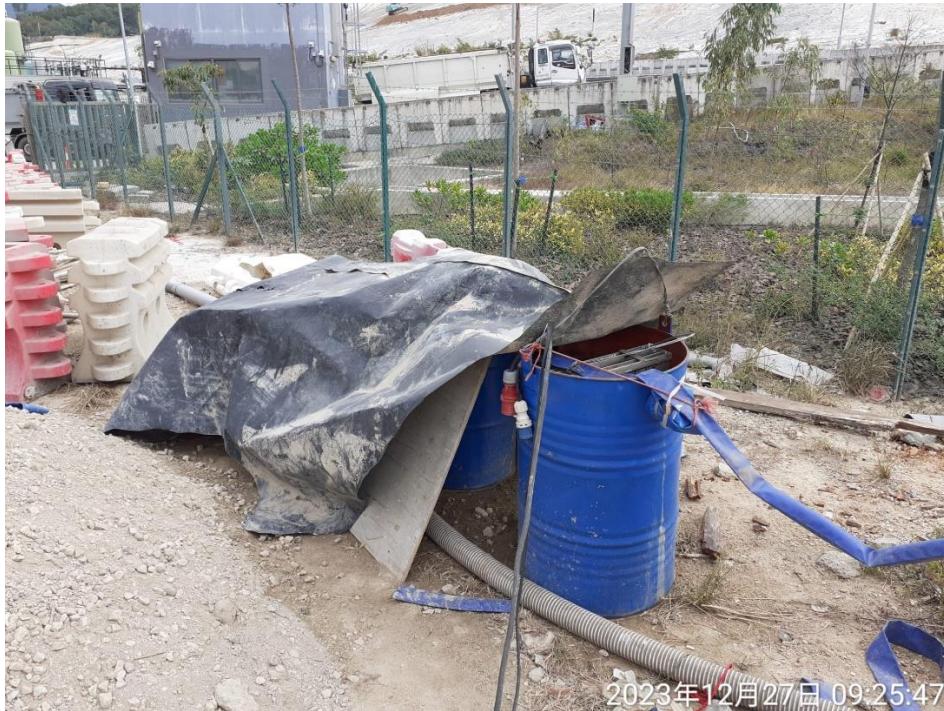
Appendix B – Photo Records from sedimentation tank.

Sedimentation tank was provided.

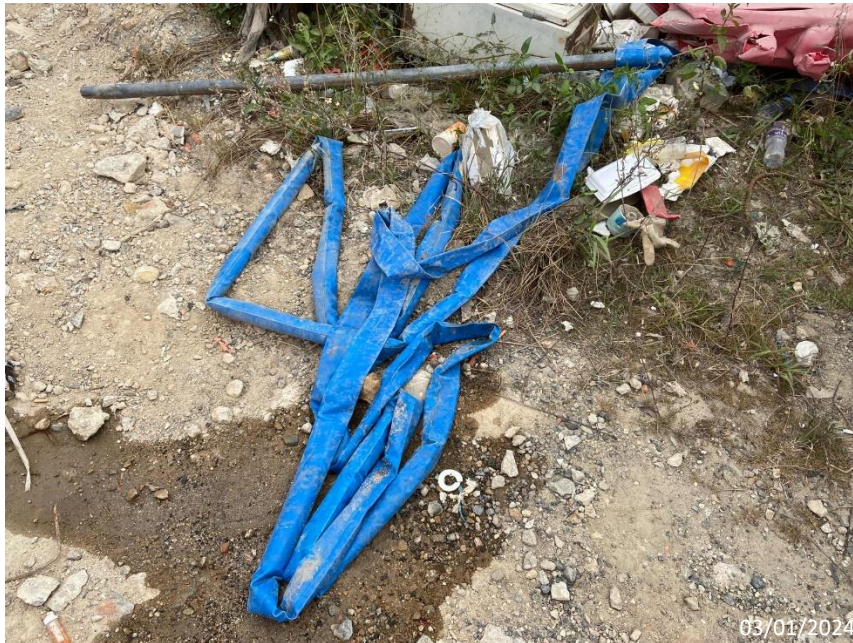
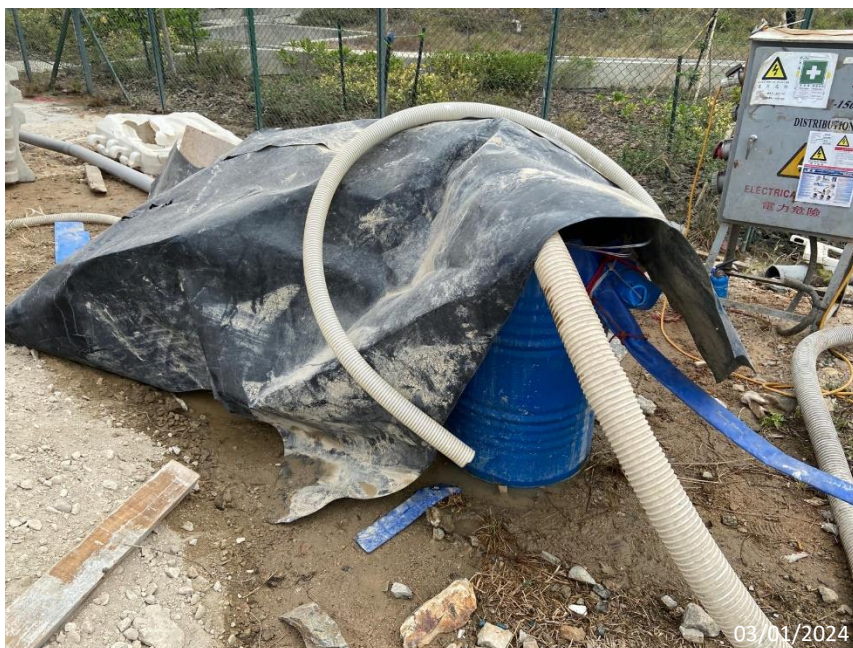
Appendix C – Photo Records for Investigation

Contractor has removed the water pipeline of the sedimentation tank.

Actions taken / to be taken	<p>The responsible contractor has been recommended to improve the dewatering works measures due to no communal storm water drain as a discharge point at 137 Pit C (e.g., soak away)</p> <p>The contractor reminded to follow the discharge license (license no. WT0032336-2018) issued by Environmental Protection Department under Water Control Ordinance. The muddy water should be treated before discharge and the water quality should fulfill the requirements of the discharge license.</p> <p>Moreover, ET will perform spot checking on the concerned area the implementation status of mitigation measures. Contractor is reminded to comply with all regulations and requirement stipulated in the EM&A Manual.</p>
